Technical Bulletin T-30714 (Mar 7, 2014)

Model : Linkbox 8000HD Local/ 8000HD Plus

Problem : No menu/No picture, Wrong LED display. ERom upgrade does not work, etc

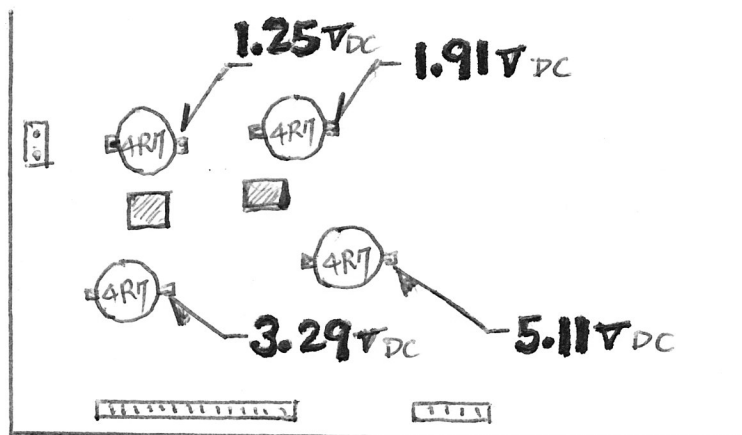
Cause of problem: One or two inductor (4R7) among 4 that are located on the left front side of main PCB board was damaged. Damage was done by factory assembly machine.

How to check problem parts : Check the 4R7 inductor's right leg voltage and if it does not meet the standard voltage and is more than 5-10% lower, it means that is damaged. These damaged 4R7 parts will be too hot when touched with the finger. In most cases , we found one or two damaged among four.

How to fix : Remove the damaged parts and replace with a new one.
